## **Hardfacing in Power Plant Applications: Challenges and Solutions**

# F91 HARDFACING DELAMINATION AND CRACKING

# In-Service Failure Modes in Valve Hardfacing

**BRO-F91-07-26**

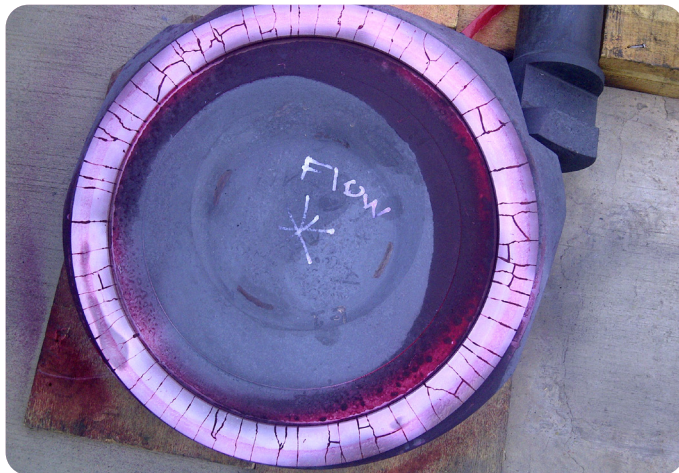
### Radial (Transverse) Cracking

Cracks initiate within the hardfacing layer and propagate through the deposited Stellite™ material, driven by excessive thermal and mechanical stresses beyond the interface's capacity to accommodate service conditions.

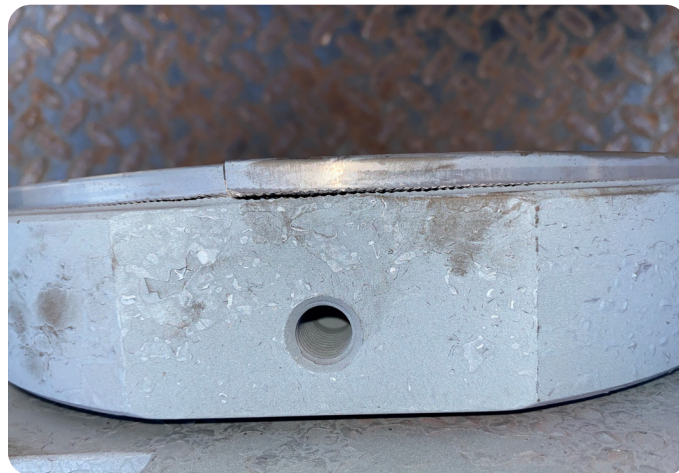
### Delamination (Disbonding / Interfacial Cracking)

Delamination occurs when the hardfacing layer separates from the F91 base material, typically initiating at the fusion line or butter layer region. This interfacial failure leads to circumferential cracking and progressive loss of adhesion between the deposited layer and the substrate.

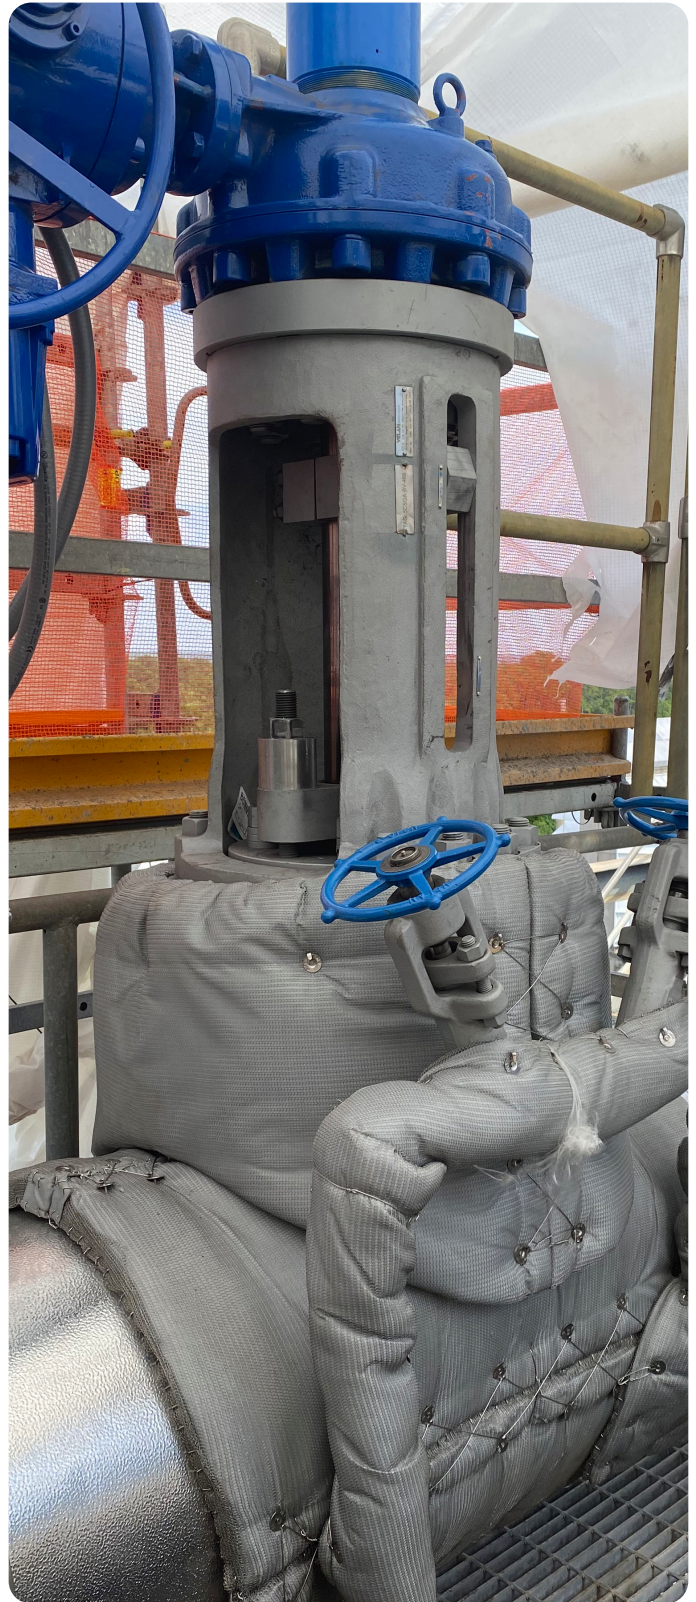
When hardfacing delaminates, liberated metal fragments can be entrained in high-energy steam flow and transported downstream. In severe cases, these particles may:

Stellite™ hardfacing delamination of a seat ring\*

Stellite™ debris\*

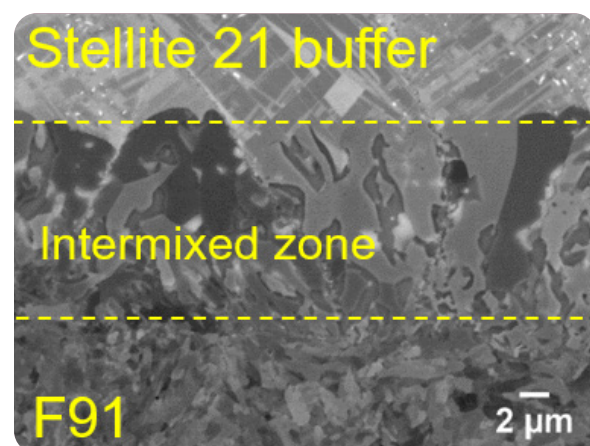
### Traditional Stellite™ 21 Buffer Layer

The results further showed that traditional Stellite™ 21 buffer layers can undergo progressive microstructural changes, leading to increased hardness and reduced toughness over extended exposure, thereby increasing susceptibility to interfacial degradation and delamination under demanding operating conditions.

Aged microstructure showing interfacial degradation mechanisms

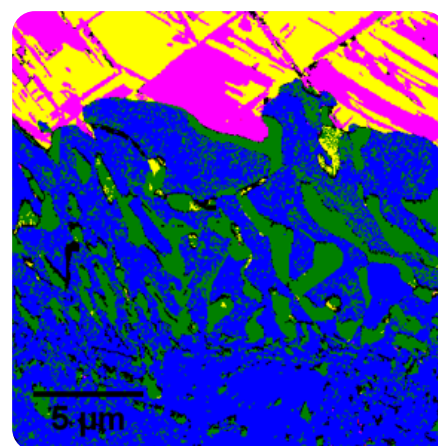
Advanced analysis of the hardfacing interface identifying the metallurgical changes associated with delamination

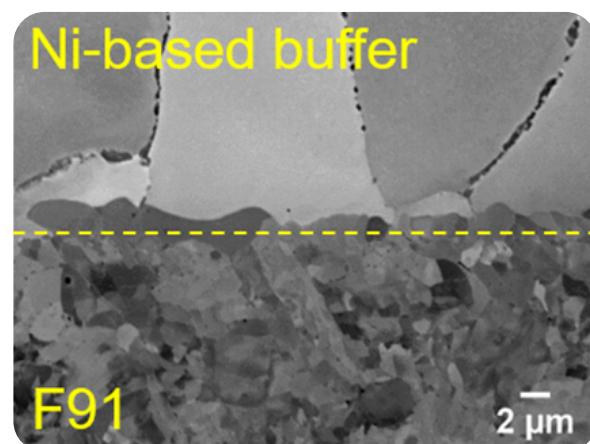
### Nickel-Based Buffer Layer

It also enabled the validation of the stability and performance of the alternative nickel-based buffer layer, demonstrating improved resistance to metallurgical degradation under long-term cyclic service conditions.

Aged microstructure demonstrating improved long-term stability

- Replacement of the Stellite™ 21 buffer layer with a nickel-based alloy buffer system to improve metallurgical stability under cyclic service conditions
- Retention of Stellite™ 6 hardfacing as the wear-resistant surface layer
- Optimization of welding procedures and dilution control to ensure consistent interface integrity and stable metallurgical behavior
